Service Bulletin

19-011

January 31, 2019 Version 2

Safety Recall: 2016-18 MDX and 2015-19 TLX V6 Fuel Pump

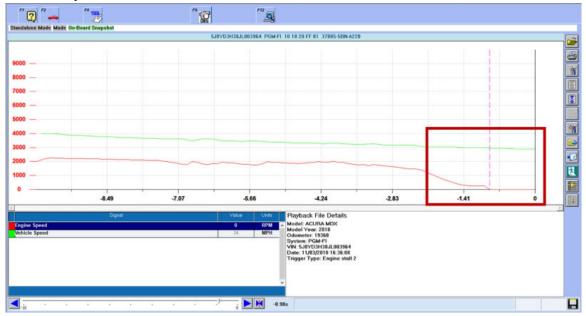
5. Select the Line Graph icon. If **Engine Speed** is 0 RPM while **Vehicle Speed** is greater than 0 MPH, the engine stalled and you must do REPAIR PROCEDURE B - PGM-FI UPDATE AND FUEL PUMP REPLACEMENT.

REPAIR PROCEDURE B - PGM-FI UPDATE AND FUEL PUMP REPLACEMENT
